# ***Juneau Douglas Wastewater Treatment Plant Structural Evaluation and Safety Upgrades***

**February 28, 2014**  
R&M Project No. 131434

## **JUNEAU-DOUGLAS WASTEWATER TREATMENT PLANT**

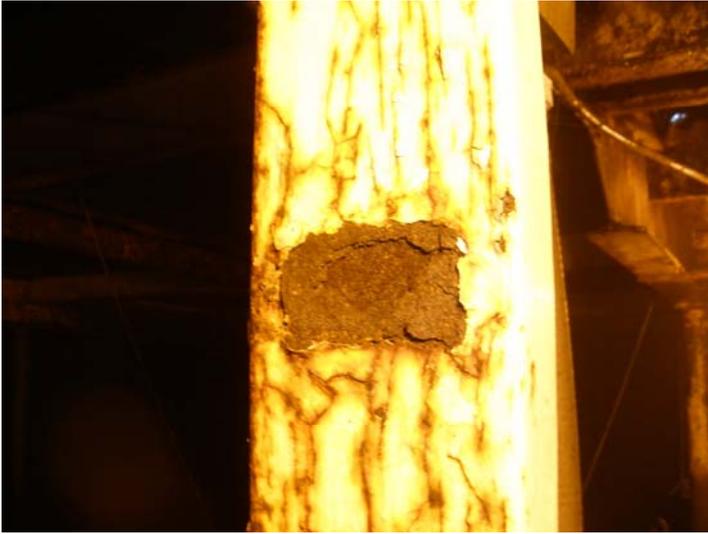
The steel frames in this building have more severe corrosion than the Aerator Buildings. Rust, particularly at the corners, has penetrated below the surface of the steel, resulting in some flaking rust and pitting of the surface. There are small holes drilled through the 3/16-inch thickness tubes in two locations where pitting was evident. These holes were inspected and appear to be in similar condition to that of the inspection from 2010 with adequate thickness of steel to safely carry all the loads from the access catwalks (see photographs in Appendix A). However, given the advanced state of rust damage in some areas, the steel section will continue to be reduced as rusting continues.

**Figure 1:** Vertical HSS5x2x3/16 in Digester Building, 2010. Compare with Figure 2.

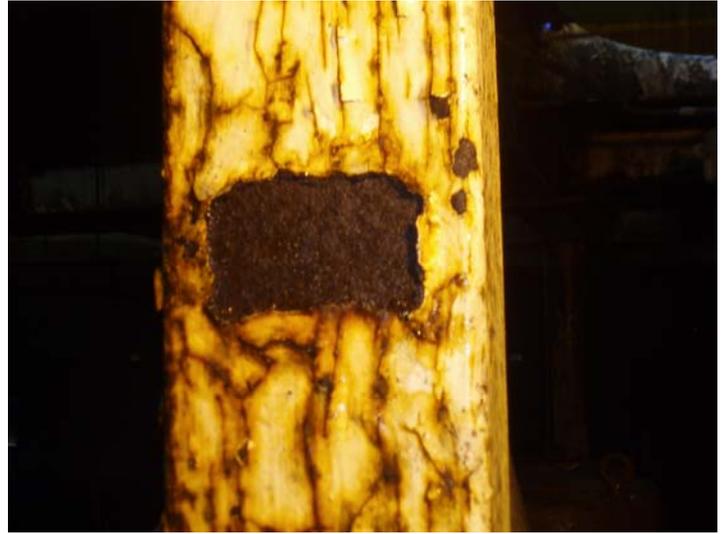
**Figure 2:** Vertical HSS5x2x3/16 in Digester Building, 2014. Compare with Figure 1.

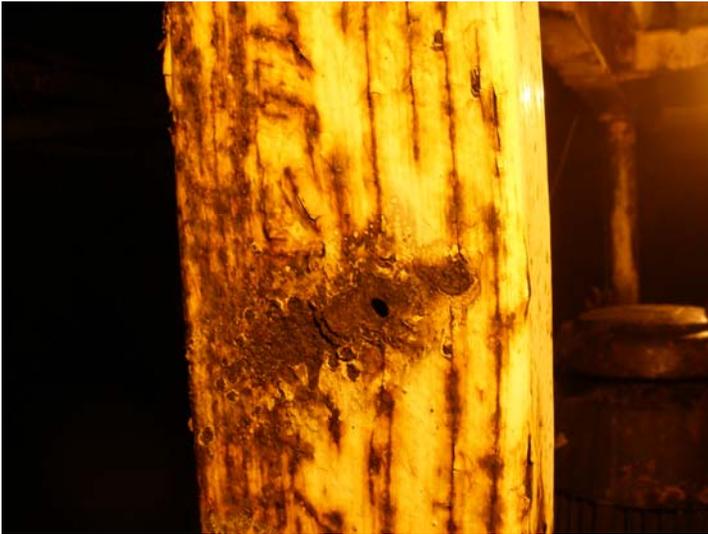
**Figure 3:** Vertical HSS5x2x3/16 in Digester Building, 2010. Compare with Figure 4.

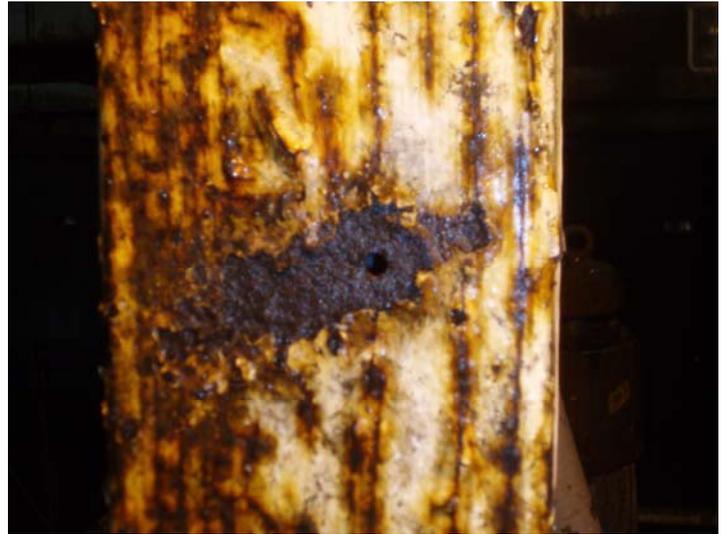
**Figure 4:** Vertical HSS5x2x3/16 in Digester Building, 2014. Compare with Figure 3.

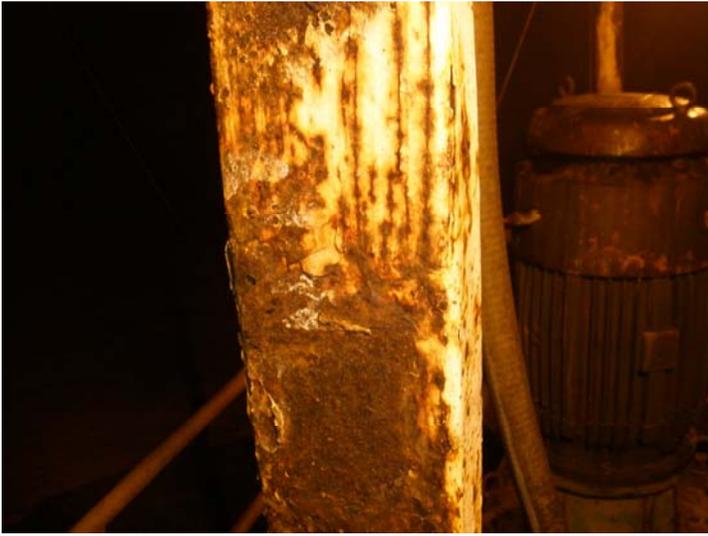
**Figure 5: Vertical HSS5x2x3/16 in Digester Building, 2010. Compare with Figure 6.**

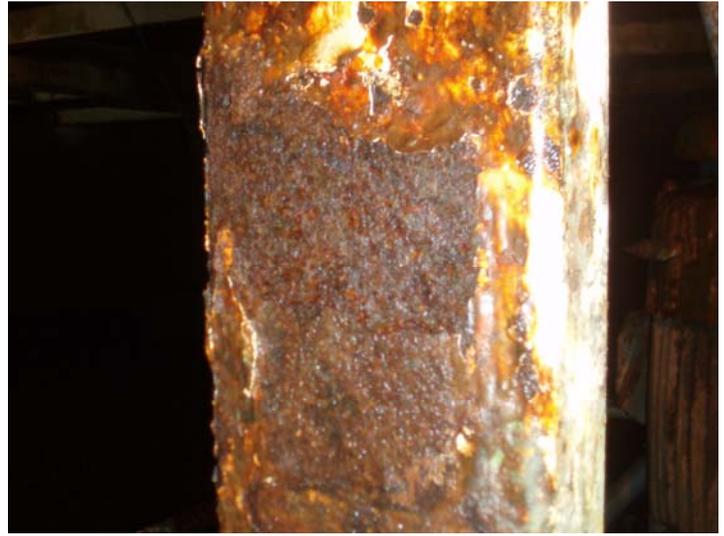
**Figure 6: Vertical HSS5x2x3/16 in Digester Building, 2014. Compare with Figure 5.**

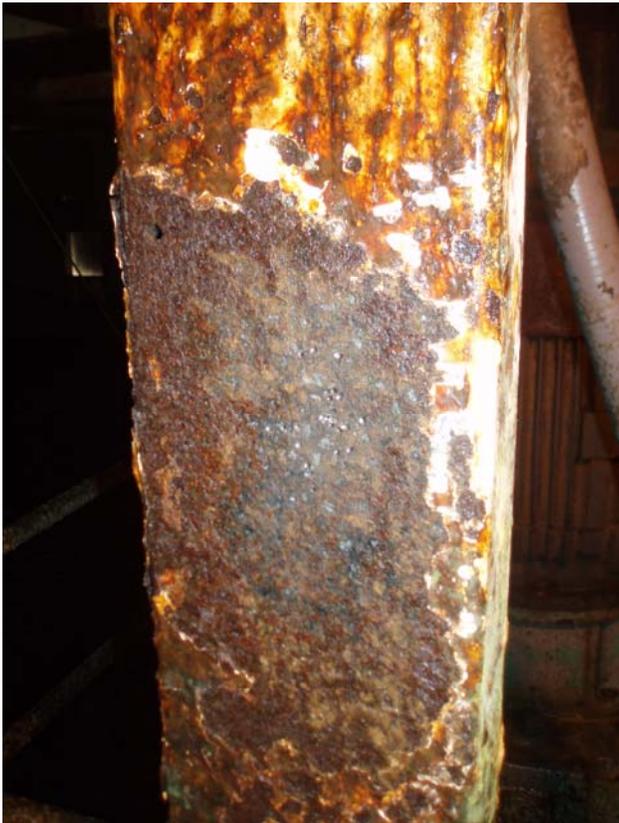
**Figure 7: Vertical HSS5x2x3/16 in Digester Building, 2014. Steel tested and inspected.**

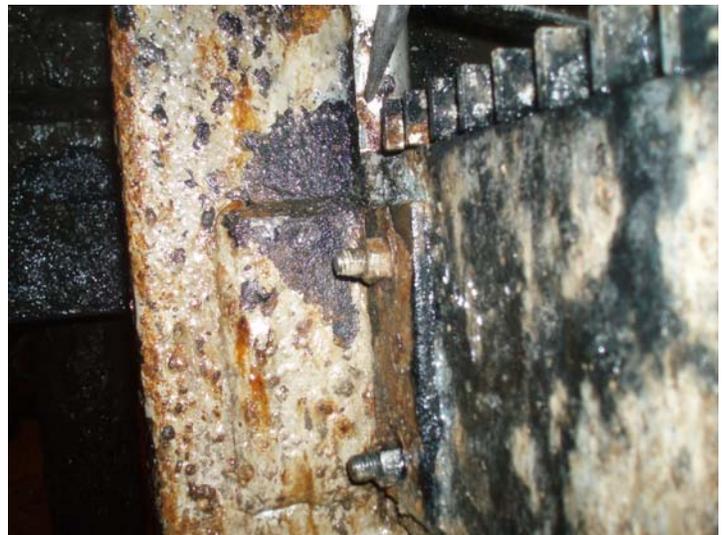
**Figure 8: Steel Angle Bracket Connecting Vertical HSS5x2x3/16 to Aluminum Channel in Aeration Building No. 1, 2014. Steel tested and inspected.**
