# ***Juneau Douglas Wastewater Treatment Plant Structural Evaluation and Safety Upgrades***

**February 28, 2014**  
R&M Project No. 131434

## **JUNEAU-DOUGLAS WASTEWATER TREATMENT PLANT**

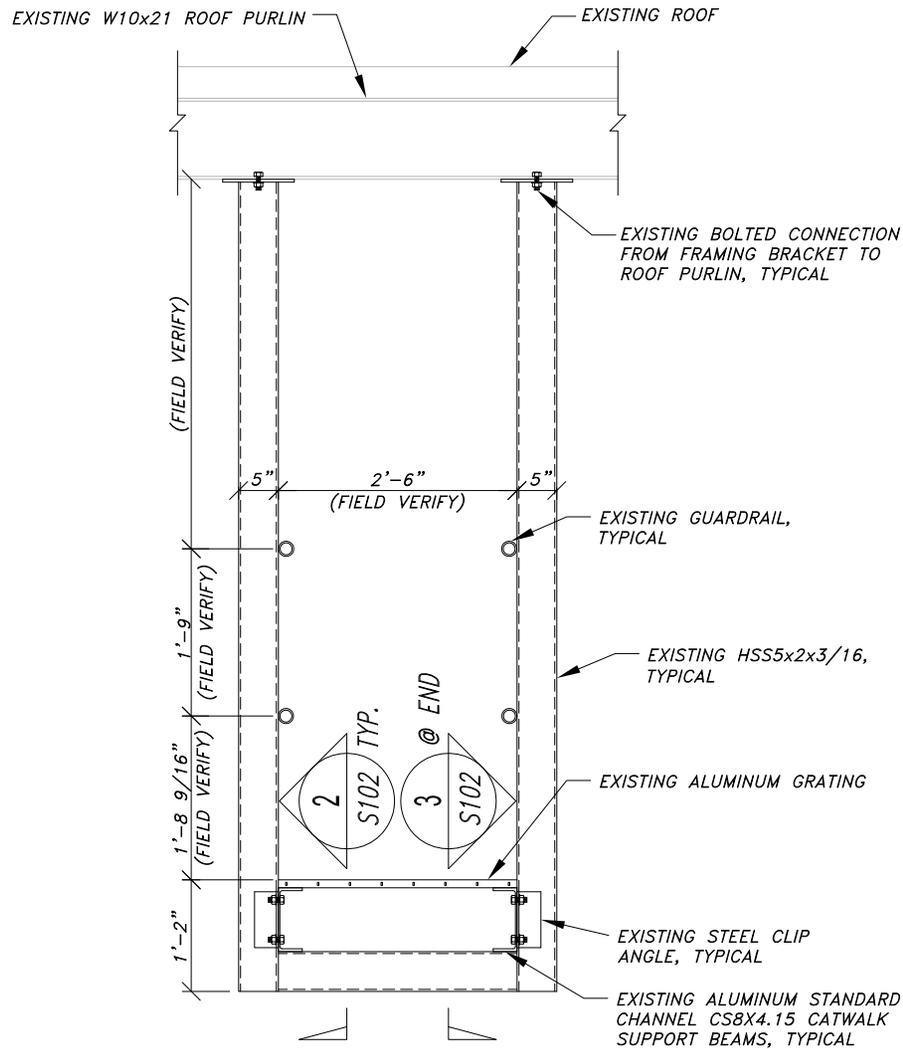
**1 CATWALK & SUPPORT FRAMES**  
SCALE: 1/2"=1'-0"

The steel support frames at approximately 10-foot spacing consist of vertical tube steel, TS5x2x3/16 inch sections with the same size tube welded between the bottom, narrow faces of the verticals to form a U-shaped frame. The vertical members are 8-foot 6-inches long, per the plans, with a bolted connection to the bottom flange of the steel, roof purlins. The roof purlins are noted on the plans as W10x21 and they span 20 feet between the roof girders. The bolted connection consists of two (2) 5/8-inch diameter bolts in direct tension at each tube, a total of four (4) bolts for each frame. None of these bolts were removed for inspection. Since these bolts are in direct tension, a failure would be sudden and would result in total collapse of a section of catwalk. Typical use of the catwalk is for personnel access only, but the most significant loading event is at the removal of the motor or mechanical equipment from the aerator via the catwalk. Given the age of the structure, the consequence of failure and the relative ease of replacement of the bolts, we recommend replacing all tension bolts with new hot-dip galvanized steel bolts.

1. The steel U-frames have sufficient structural strength in their current condition to give a useable life of at least 10 years.
2. The safety upgrades of the catwalk should thus be limited to replacement of the aluminum grating, catwalk beams and guardrails.
3. The tension bolts connecting the steel U-frames to the roof purlins should be replaced with new 5/8-inch hot-dip galvanized steel bolts.
